MHI Services Inc.
Property Inspection Report

333 Some place Ave, Some Place OR, 970245
Inspection prepared for: SAMPLE REPORT & SAMPLE REPORT
Inspection Date: 3/29/2009 Time: 8AM
Age: 9 YEARS Size: 3400 SQ FT
Weather: Rain/56 Degrees

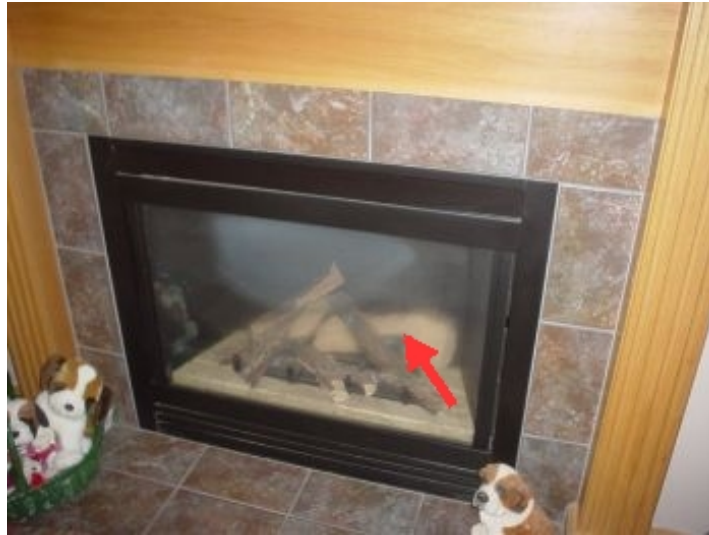
Interior Areas Fireplace

- gas only
- visible soot like material was noted on glass.
 this could indicate possible venting or other conditions present
- recommend contractor to evaluate

| Interior Areas | | |
|---|---|---|
| Page 3 Item: 9 | Fireplace | <ul style="list-style-type: none"> • visible soot like material was noted on glass. this could indicate possible venting or other conditions present • recommend contractor to evaluate |

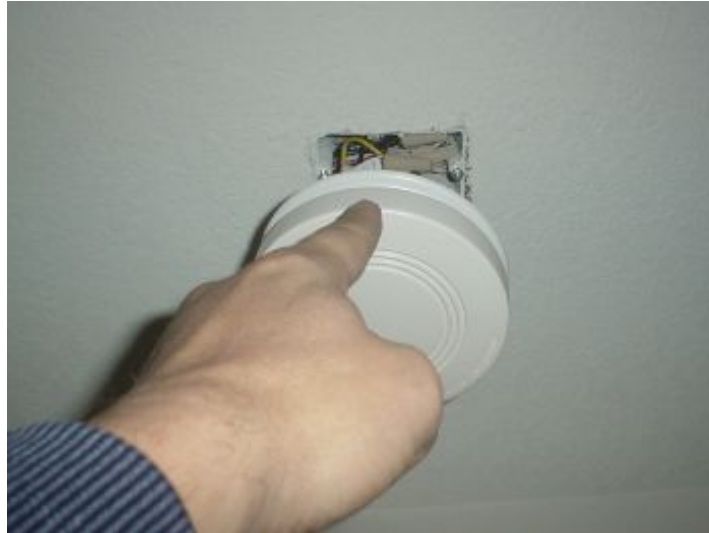
Interior Areas Smoke Detectors

Observations:
 • operated
 • Noted smoke detector down stairs disconnected from base and hanging from wires. this is a safety issue and needs to be corrected as soon as possible.

| Interior Areas | | |
|---|---|---|
| Page 4 Item: 14 | Smoke Detectors | <ul style="list-style-type: none"> • Noted smoke detector down stairs disconnected from base and hanging from wires.this is a safety issue and needs to be corrected as soon as possible. |

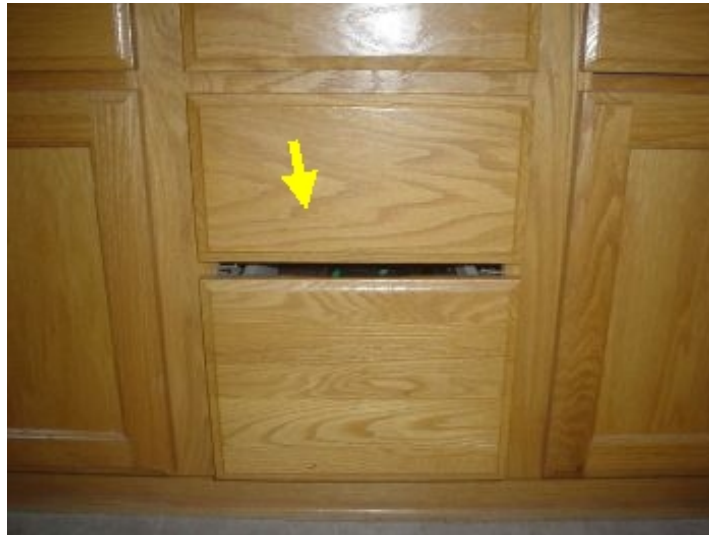
Bathroom Cabinets

- functional
- damaged/missing wood between cabinet drawers
- functional

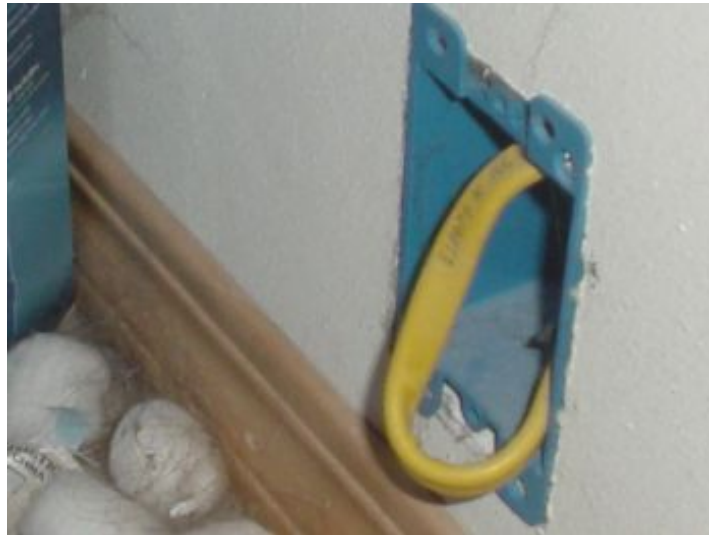
Bathroom Electrical

- exposed wires
- missing j-box cover

| Interior Areas | | |
|---|---|---|
| Page 8 Item: 6 | Electrical | <ul style="list-style-type: none"> • exposed wires • missing j-box cover |

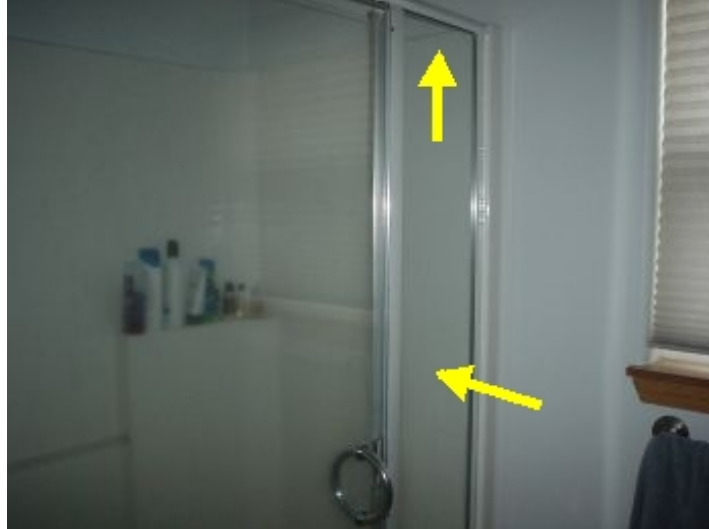
Bathroom Showers

- functional
- functional
- shower enclosure glass loose in frame
- recommend repair or replace by a qualified person

| Interior Areas | | |
|---|---|---|
| Page 9 Item: 14 | Showers | <ul style="list-style-type: none"> • functional • shower enclosure glass loose in frame recommend repair or replace by a qualified person |

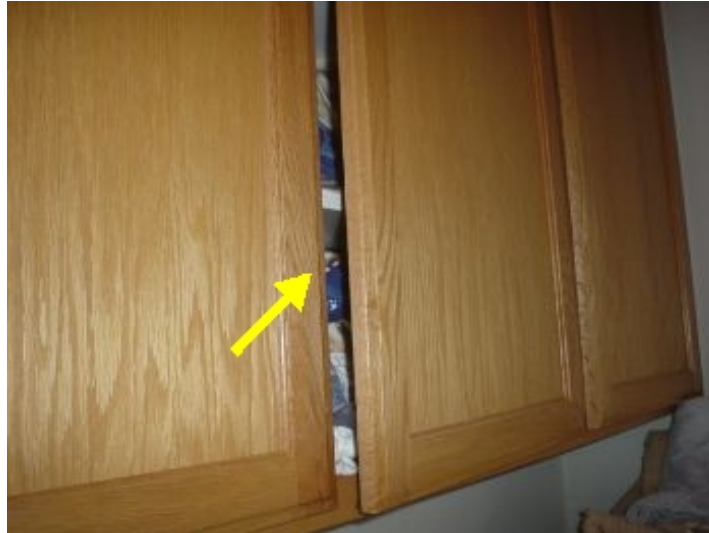
Laundry Cabinets

Observations:
 • doors did not close completely

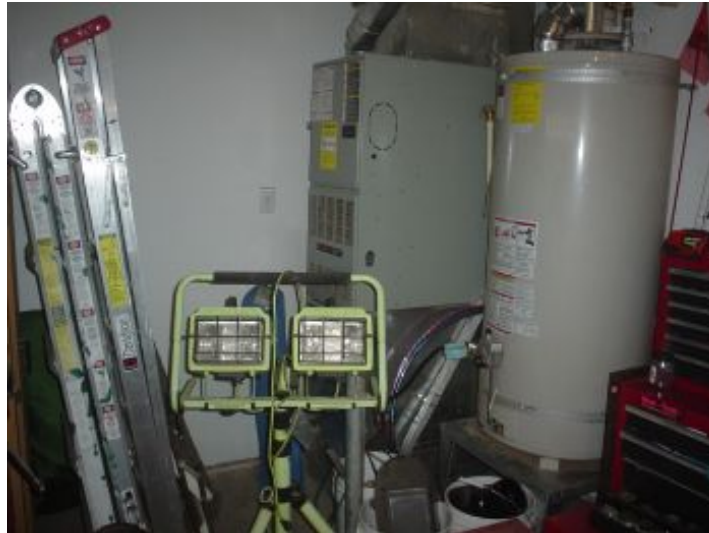
Water Heater Water Heater Condition

Materials: gas
 Materials: garage
 Observations:
 • operated
 • deteriorated unit
 • evidence of leaking

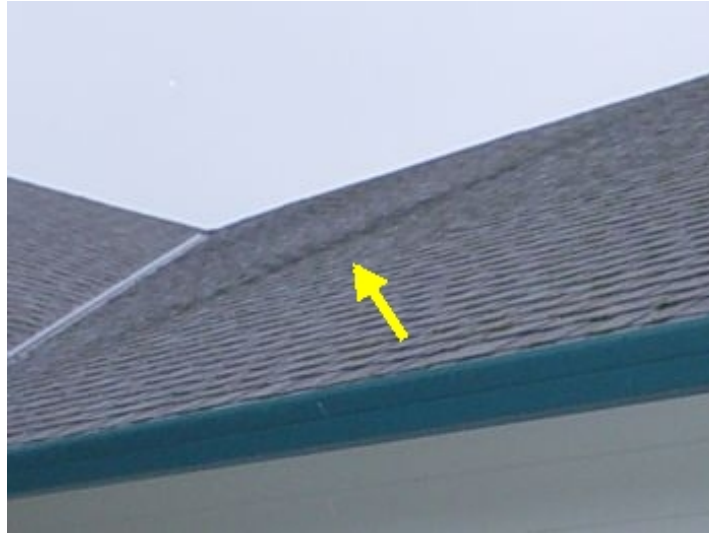
Roof Roof Condition

- deflection note on roof,with closer inspection it appears to be cosmetic

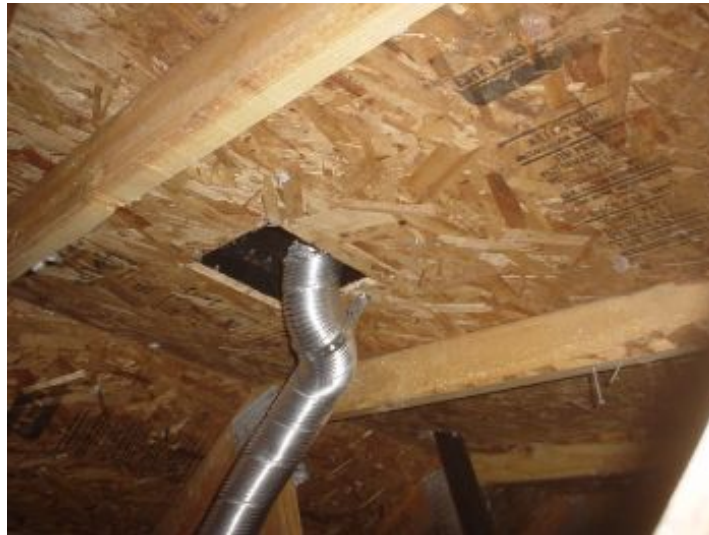
Attic Exhaust Vent

- damaged flex vent
- terminates in the attic
- recommend a licensed contractor evaluate

| Interior Areas | | |
|---|---|---|
| Page 25 Item: 5 | Exhaust Vent | <ul style="list-style-type: none"> • terminates in the attic • recommend a licensed contractor evaluate |

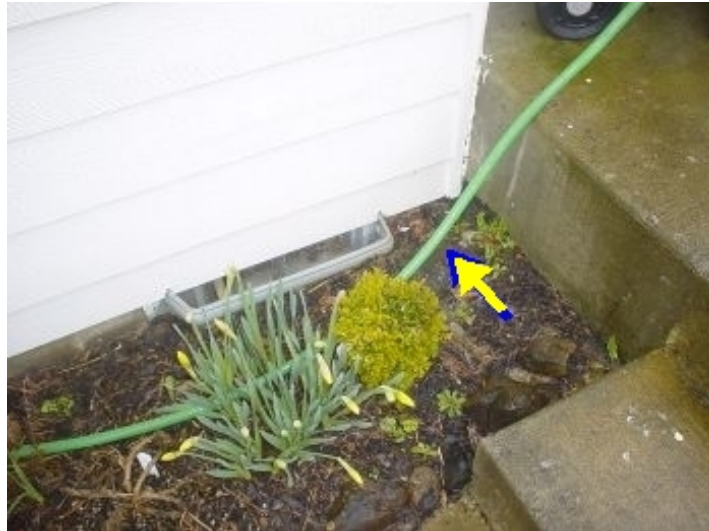
Exterior Areas Siding Condition

Materials: cement hardy plank
 Observations:
 • earth to wood contact
 • wood in contact the ground can cause wood rot and attracted wood destroying insects.
 • earth to wood contact

| Interior Areas | | |
|---|---|---|
| Page 26 Item: 4 | Siding Condition | <ul style="list-style-type: none"> • earth to wood contact |

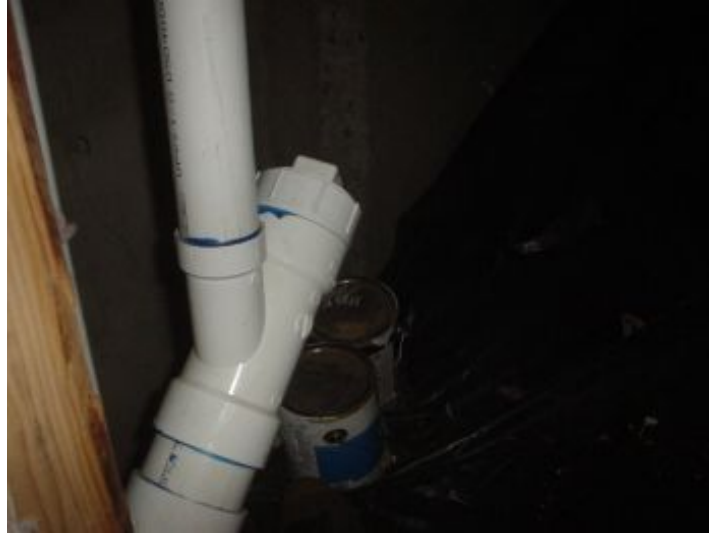
Foundation Foundation Plumbing

- main access sewer clean out located in crawl space

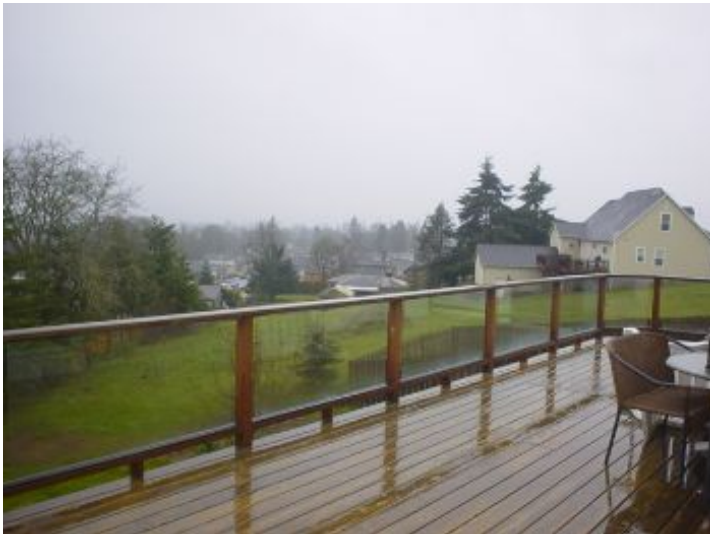
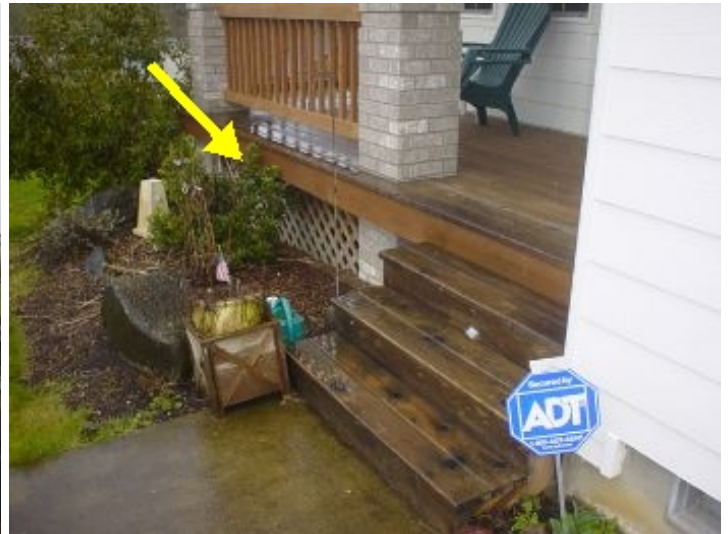
Grounds Stairs & Handrail

Observations:
 • functional
 • loose railing
 • recommend hand rails

| Interior Areas | | |
|---|---|---|
| Page 29 Item: 6 | Stairs & Handrail | <ul style="list-style-type: none"> • recommend hand rails |

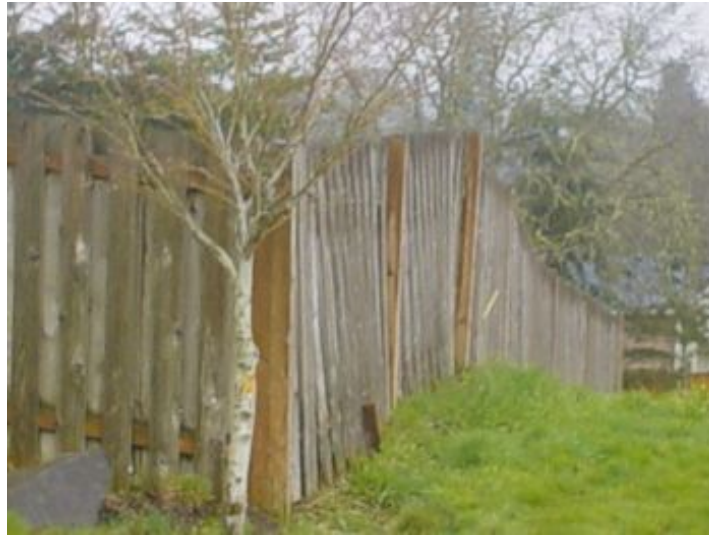
Grounds Fence Condition

Materials: wood
 Observations:
 • earth to wood contact
 • deteriorated wood
 • weathered

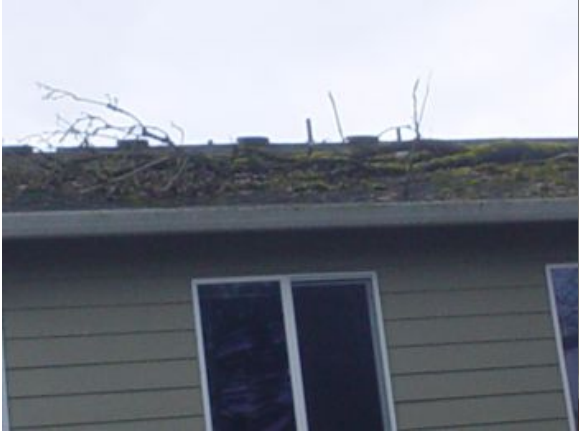
deflection note on roof,with closer inspection it appears to be cosmetic
